UNDERSTANDING THE IMPACT OF NATURAL PHENOMENA ON YOUR CAPESTONE

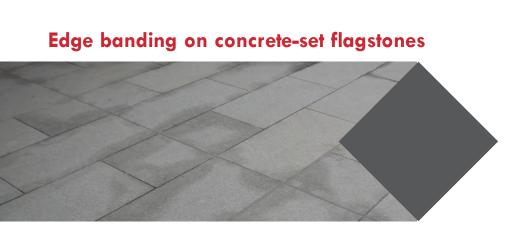
Description: Formation of cement staining resembling a picture frame around flagstones, visible a few days after installation.

Impact: Primarily occurs when wet cement slurry grout is used for joint filling.

Explanation: Cement-contaminated water from the grout is absorbed by the flagstones, creating a "transport chain" that leads to staining.

Mitigation: To prevent staining, use approved grouting materials that provide a flexible joint and minimize the chance of staining.

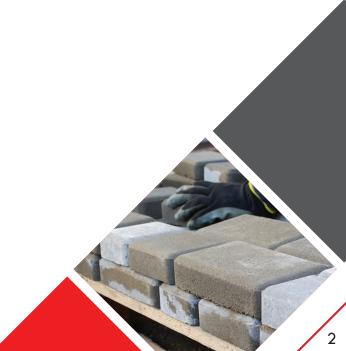
Efflorescence: White Deposits on Pavers

Description: White salt deposits that may appear on or near the surface of concrete, clay, and natural stone products.

Impact: Efflorescence causes temporary discoloration but doesn't affect the performance or structural integrity of Capestone.

Explanation: Efflorescence can arise from within the concrete or from the sub-grade beneath the pavers. It gradually diminishes over time and affects various shades, although lighter-colored pavers may show it to a lesser degree.

Mitigation: Efflorescence naturally dissipates, and there are specialized products available to safely and effectively remove the deposits.
